Dual-Core Intel[®] Xeon[®] Processor 7100 Series

Specification Update

October 2006

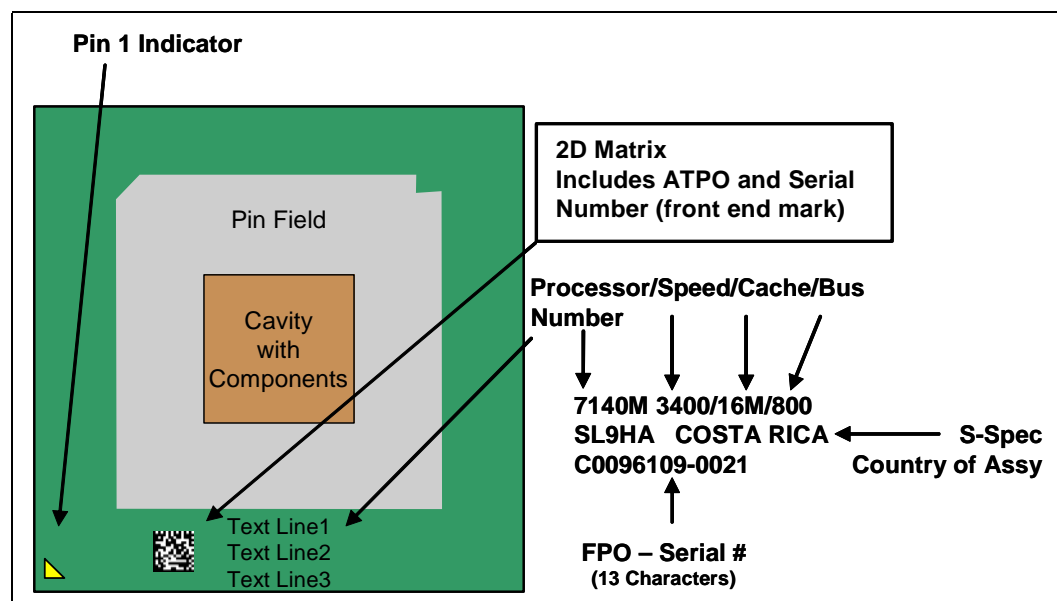
Figure 3-5. Processor Bottom-Side Markings has been updated to include a 2D Matrix.
